# Therikulam Pond

Detailed study on Therikulam Pond of 13<sup>th</sup> Ward of Kalamassery Municipality

### PRE-PROJECT STUDY

Pre-project study report and Project proposal on  
Therikulam Pond, 13<sup>th</sup> Ward of Kalamassery Municipality

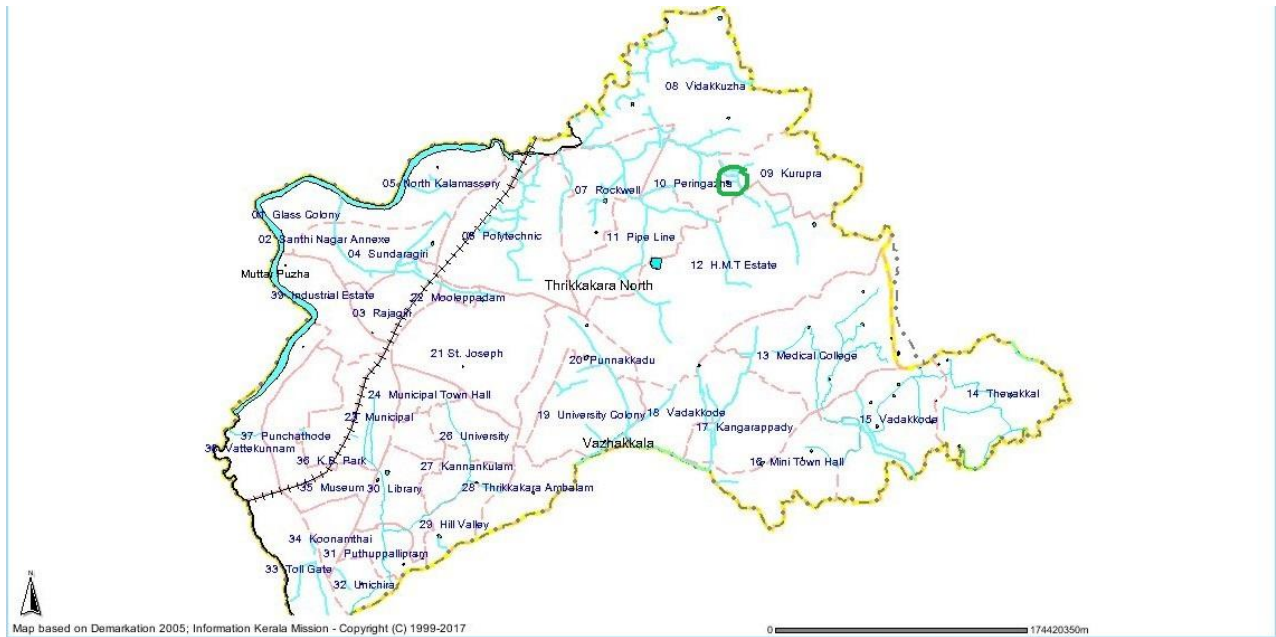
Fig.1.1 Administrative map of Kalamassery Municipality

Kalamassery is a suburb of the city of Kochi and is one of the municipalities in Ernakulam district. Located on the way to Ernakulam from Aluva through National Highway 47, Kalamassery belongs to Kanayanannur Taluk. The municipality is situated between 10° 3' 7.09" N, 76° 18' 56.78" E. As of 2001 India census, the municipality extends over an area of 27 KM<sup>2</sup> and has a population of 70,776 with an average literacy rate of 84%. Three-quarters of the city are high hills, its slopes, and the remainder is plain. Formed on the 1st of April 1990, the municipality has 42 wards. The wards are listed in the Fig 1.1. Circled in green is the approximate location of Therikulam pond.

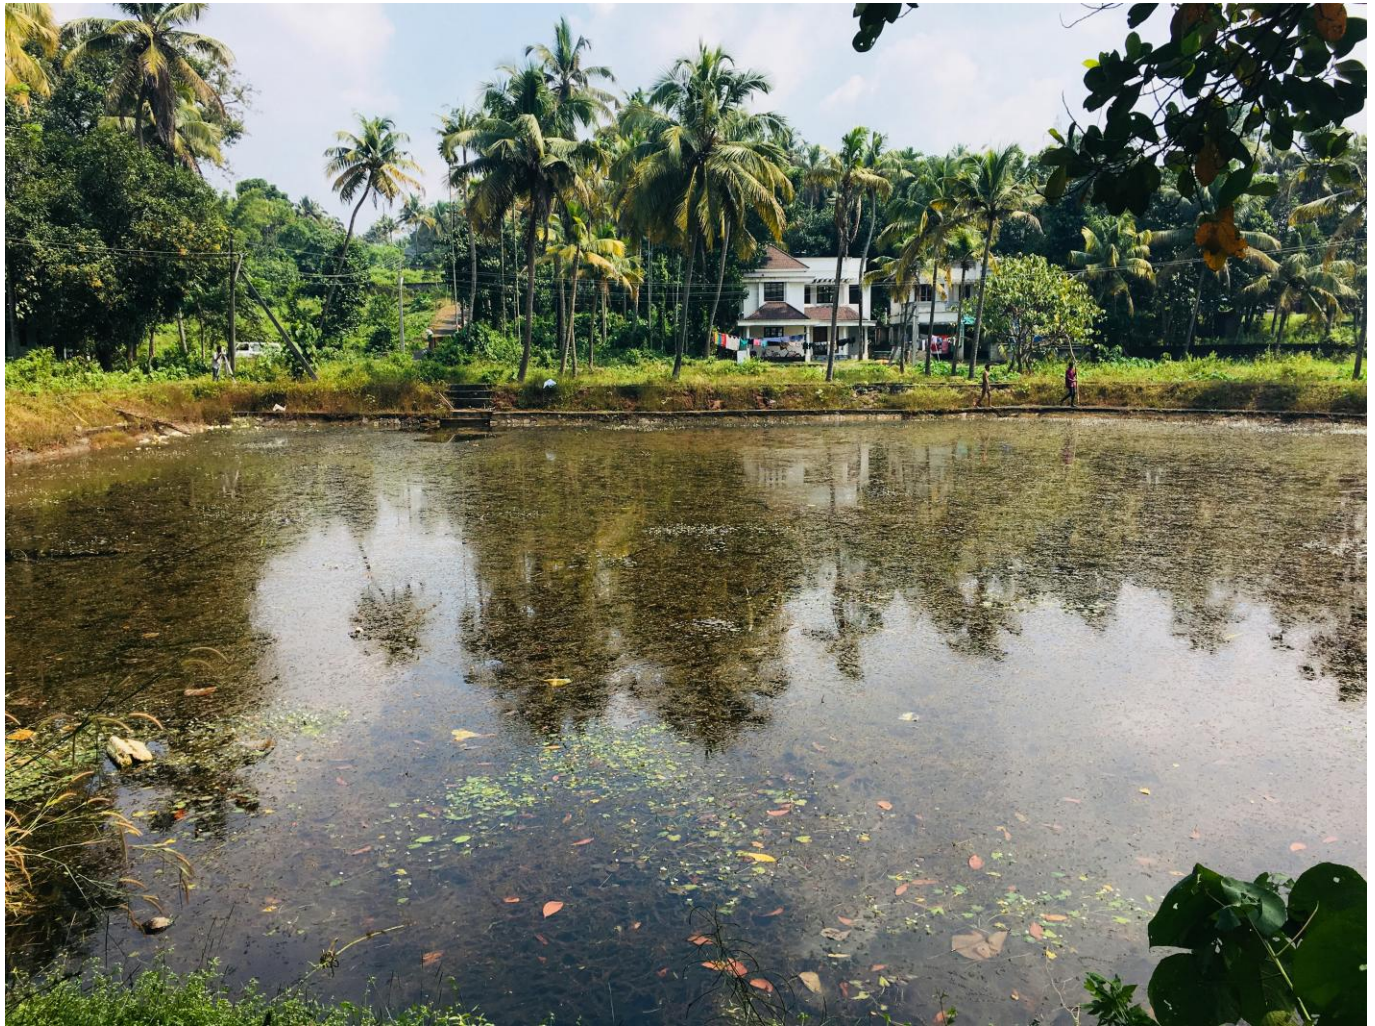
Fig 2.5 Therikulam pond and its surrounding landscape

The pond's area is rich in floral diversity. As per the respondents, the surroundings of the pond were earlier all paddy fields. However, the paddy fields were then converted to dry land by filling the paddy fields, and many houses were built on those. The pond is protected by retaining walls, and has two entrances to the pond.

There was an inlet/outlet built from the pond to a rivulet nearby. As people start to settle in the nearby areas around the pond, waste water from their houses started to come into the pond through the inlet making the water in the pond polluted. Hence, the inlet/outlet connection from the pond to the rivulet was closed. As of now, they remain closed to avoid contamination of the water in the pond. Fig 2.5 shows Therikulam pond and its surrounding landscape.

- **Weed Out:** Though plastered, the surrounding walls of the pond is covered with plants and creepers, which needs to be removed and the walls have to be properly plastered. The water in the pond is heavily filled with aquatic weeds which doesn't let people to swim or let alone enter into the pond, which also needs to be removed.

- **Retaining wall maintenance:** There are serious damages for the retaining wall at different positions of the pond, especially the top portion which needs to be plastered with concrete.

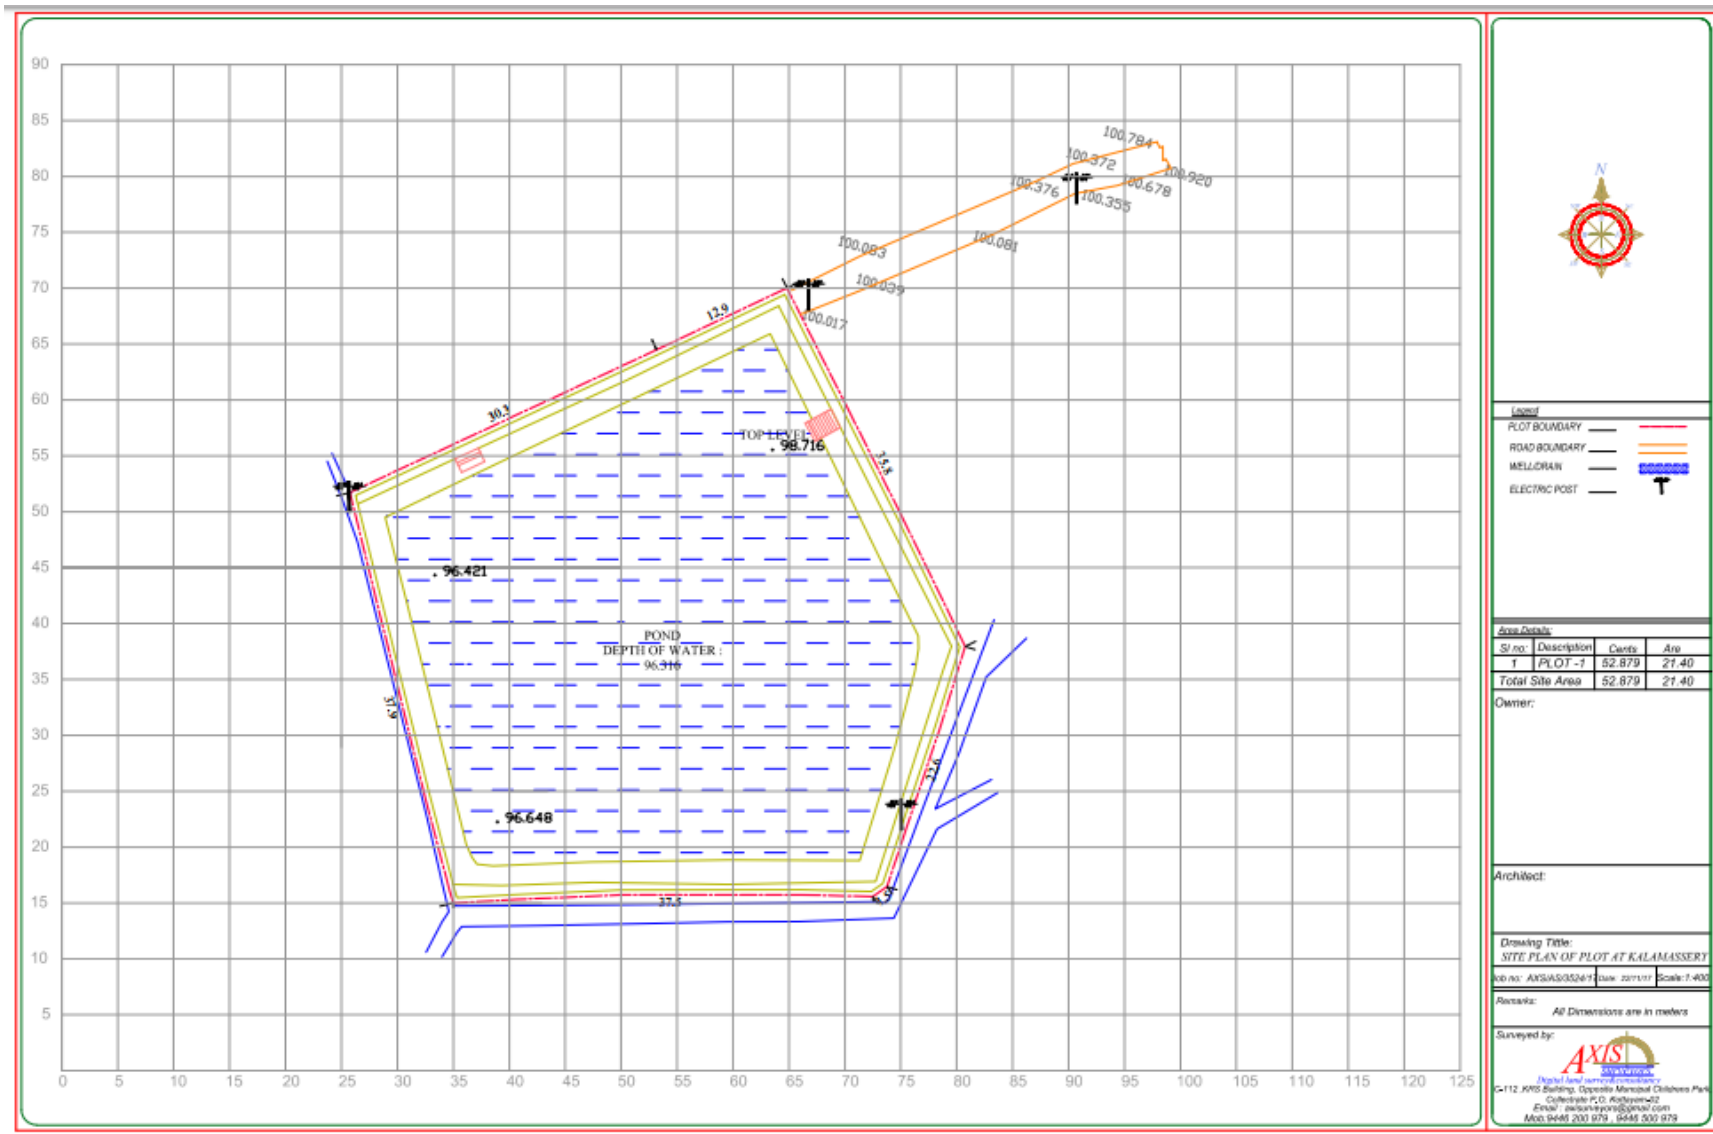
Fig. 2.8. Cross section maps of Therikul am pond showing the water and sediment levels

DATUM: +90.00	
DISTANCE	GROUND LEVEL
00.000	100.058
2.500	99.152
5.900	96.521
9.300	96.421
17.800	96.547
24.200	96.473
32.000	96.648
33.000	98.883
35.800	99.159
37.200	99.250

DATUM: +90.00	
DISTANCE	GROUND LEVEL
00.000	100.185
2.300	99.053
6.300	96.504
15.000	96.530
30.200	96.420
44.300	96.311
47.200	98.901
50.600	99.311

DATUM: +90.00	
DISTANCE	GROUND LEVEL
00.000	99.663
4.700	96.760
11.400	96.551
25.000	96.748
35.000	96.353
38.600	99.786
40.400	99.345

The cross section maps of the pond shows that on an average 2.6 meter deep water column exists in the pond during the survey period. But, further up to a depth of 1 meter sediment is deposited including clay.

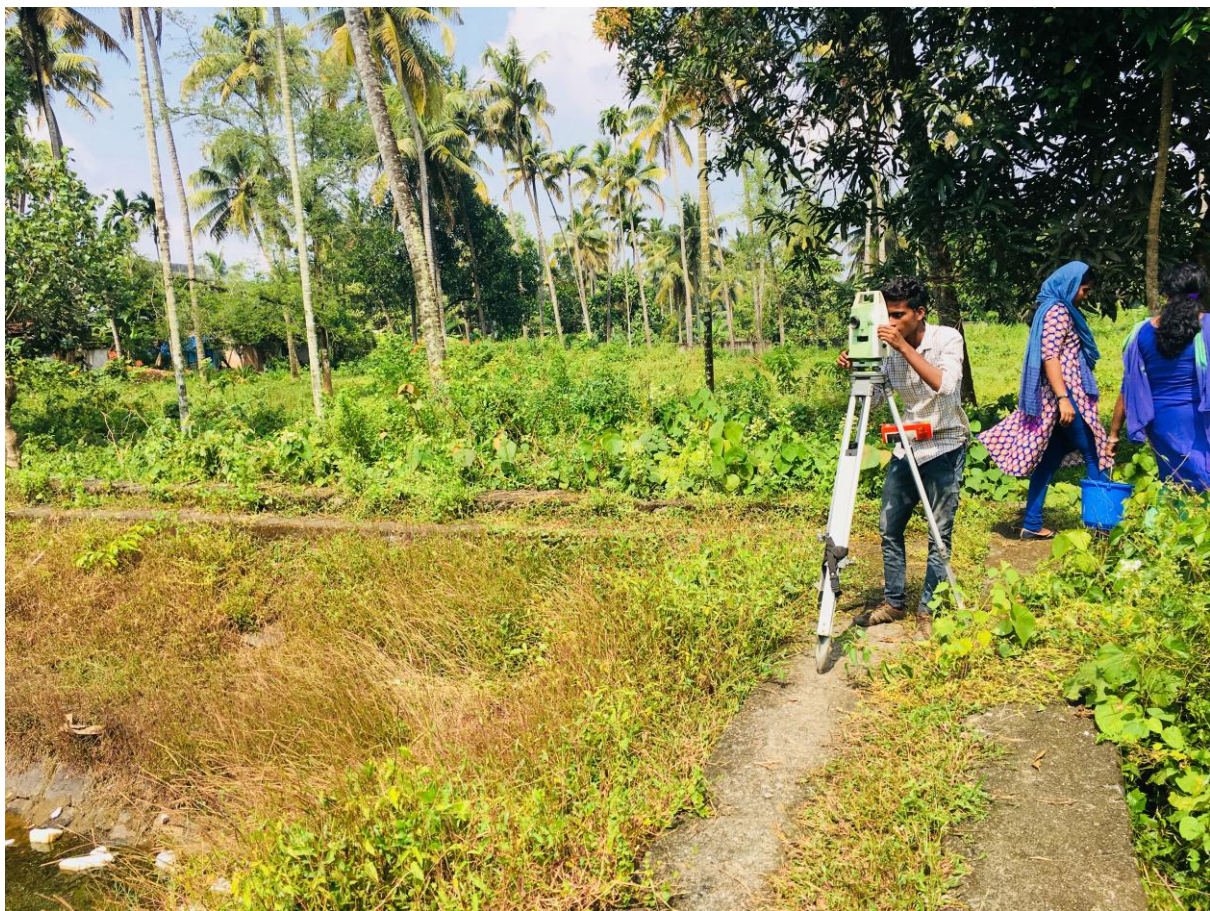
Fig 2.11. TIES' team surveying the Therikulam pond and its surroundings

The quantity of water available during the study period was estimated and it is found that center point of the pond has 2.6 meters depth and the sides of the pond are on average 2 meters deep. According to the local people, even in extreme summer, the pond doesn't dry out.

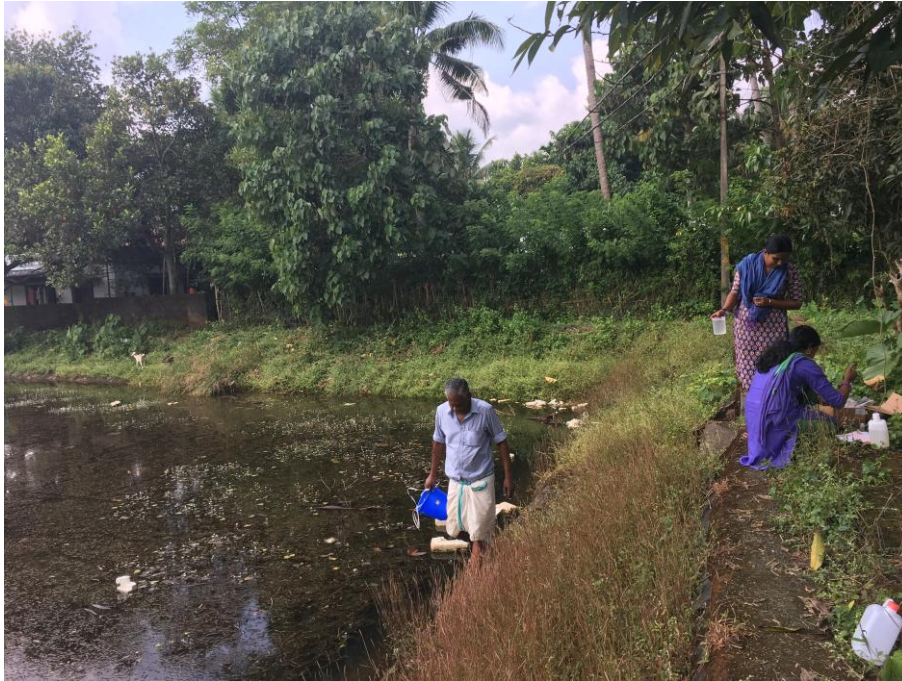
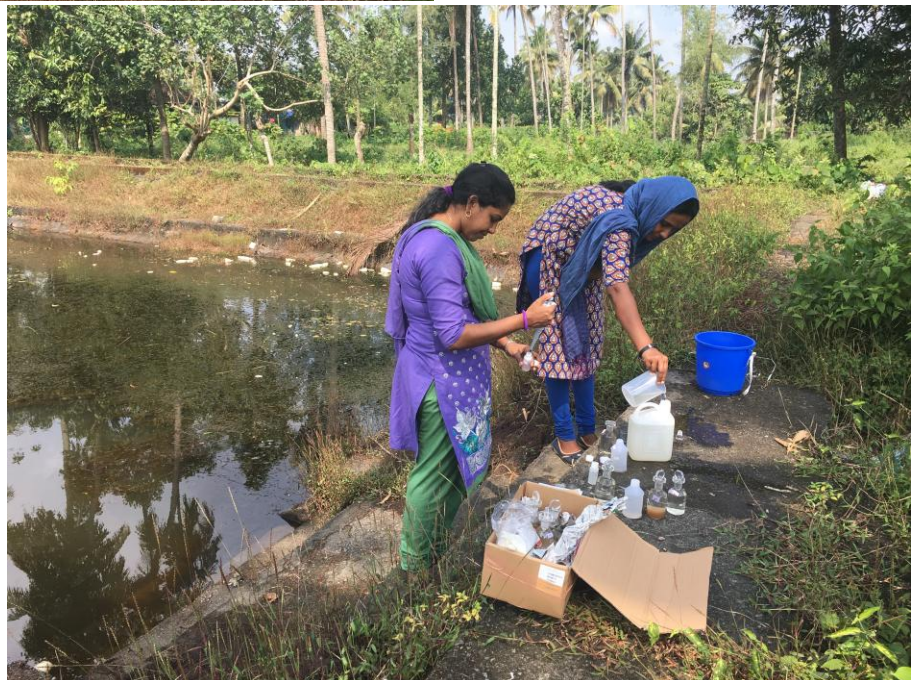
Fig. 2.12. Taking water samples for analysis from Therikulam pond

Water quality of the pond was also tested employing standard procedures. A total of 5 samples are collected from 5 different parts of the pond, (1 sample from all four corners and 1 from the center). All the samples were contaminated with coliform bacteria. Since the water has fecal contamination and has coliform bacteria, it is unfit for drinking.
