PRE-PROJECT STUDY OF PERINGAMKULAM POND REVIVAL PROGRAMME: REPORT

Report on Pre-project study of Peringankulam Pond Revival Programme

Peringankulam, a pond located on the side of NH-47 at Perambra, near Apollo Plant, Thrissur, Kerala, India.

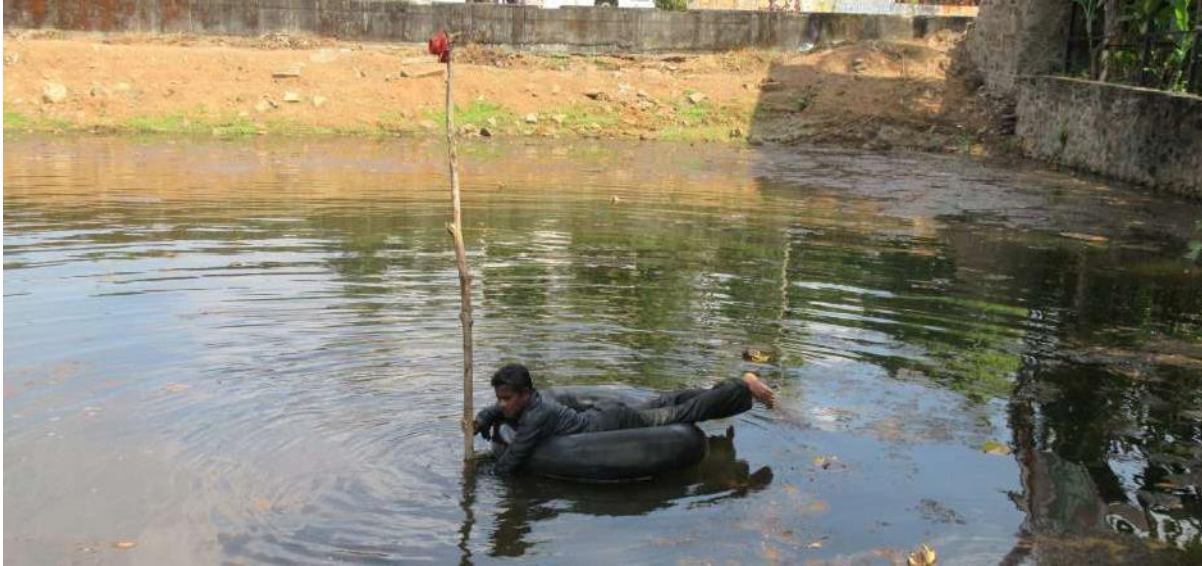
The boundary of the pond is not clearly marked and the stones are not found. On the southern side a retaining wall is built by the owner of the adjoining land but it is reported as encroachment to the pond area. The boundaries should be clearly marked and boundary wall shall be constructed with the help of Village and Panchayath offices.

Appendix 2). According to this data, currently pond and adjoining area has a total area of 42.71 cents (17 Ar 29 Sq. Links) only. As part of this study the area is surveyed on 24th January 2015 using Total Station equipment and the map is given in Fig. 9. As per this survey, pond and adjoining area has 46.89 cents (18 Ar 89 sq.links). This is excluding the 1 metre service line area of the NH, which is not marked in the location. The water filled area of the pond is 28.99 cents.

Fig. 9. Site plan of the Peringankulam Pond

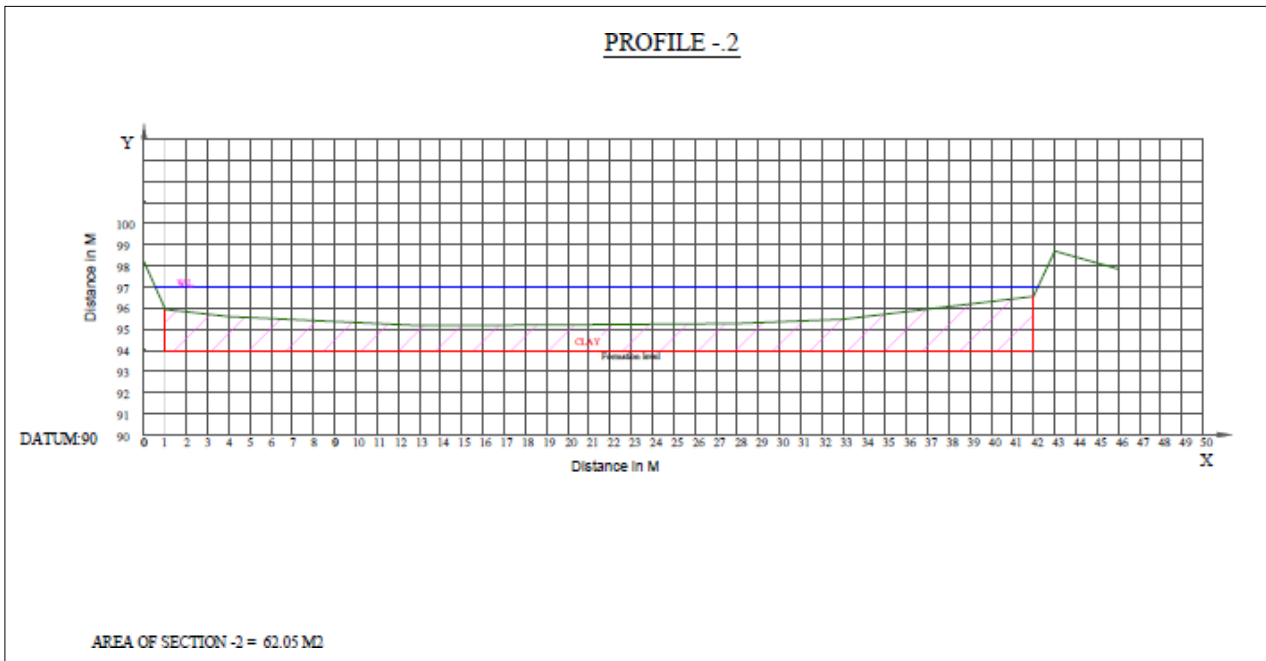
Fig. 10. Cross section 2 showing the depth and quantity of clay/sand

PROFILE 2					
BS	IS	FS	HI	RL	REMARKS
	1.925			98.200	RETAING WALL TOP
	4.190			95.935	RETAING WALL BOTTOM
	4.525			95.600	
	4.955			95.170	
	4.925			95.200	
	4.860			95.265	
	4.655			95.470	
	3.580			96.545	RETAING WALL BOTTOM
	1.430			98.695	RETAING WALL TOP
	2.275			97.850

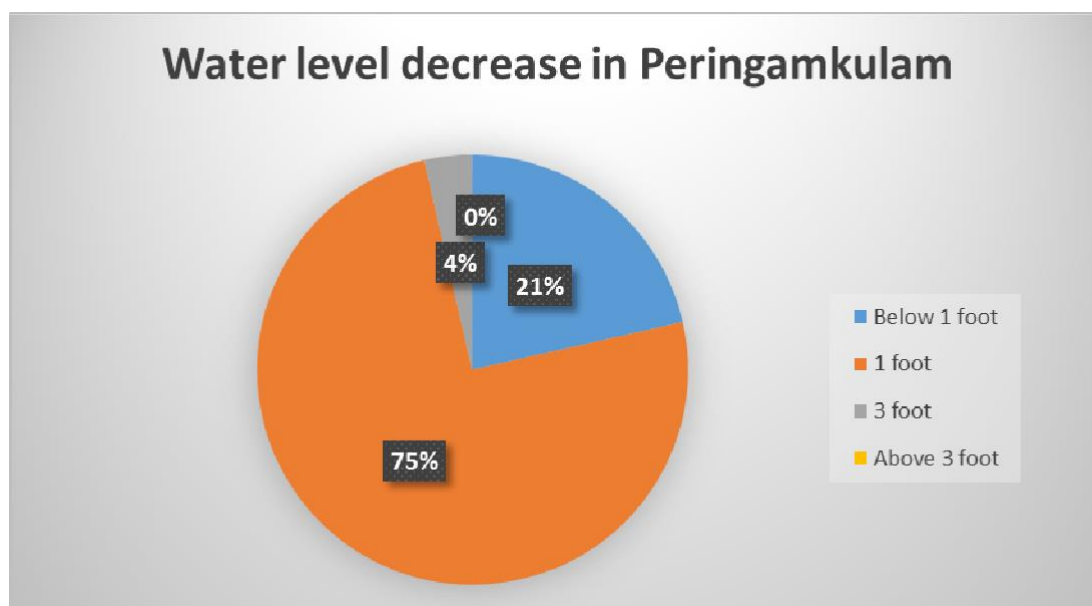
Fig.12. Opinion of stakeholders on the summer water level of Peringamkulam pond

Peringamkulam pond is a perennial source of water in that area. Among the survey respondents, 37% claimed that there is no water level fluctuation in the Peringamkulam pond and about the same percentage of respondents said that there is a water level fluctuation in the pond mainly during the summer season. Almost 25 % does not respond to that question.. According to the people mentioned about the water level fluctuation, majority claimed that almost 1 foot of water decreases during the summer season. Only 21 % of respondents said that the water level decline is below one foot and 4 % said that it is above three foot (Fig. 12). However, everybody underlines the fact that due to the existence of the pond, the local community has enough drinking water in their wells throughout the year. Pond recharges neighboring open wells significantly.

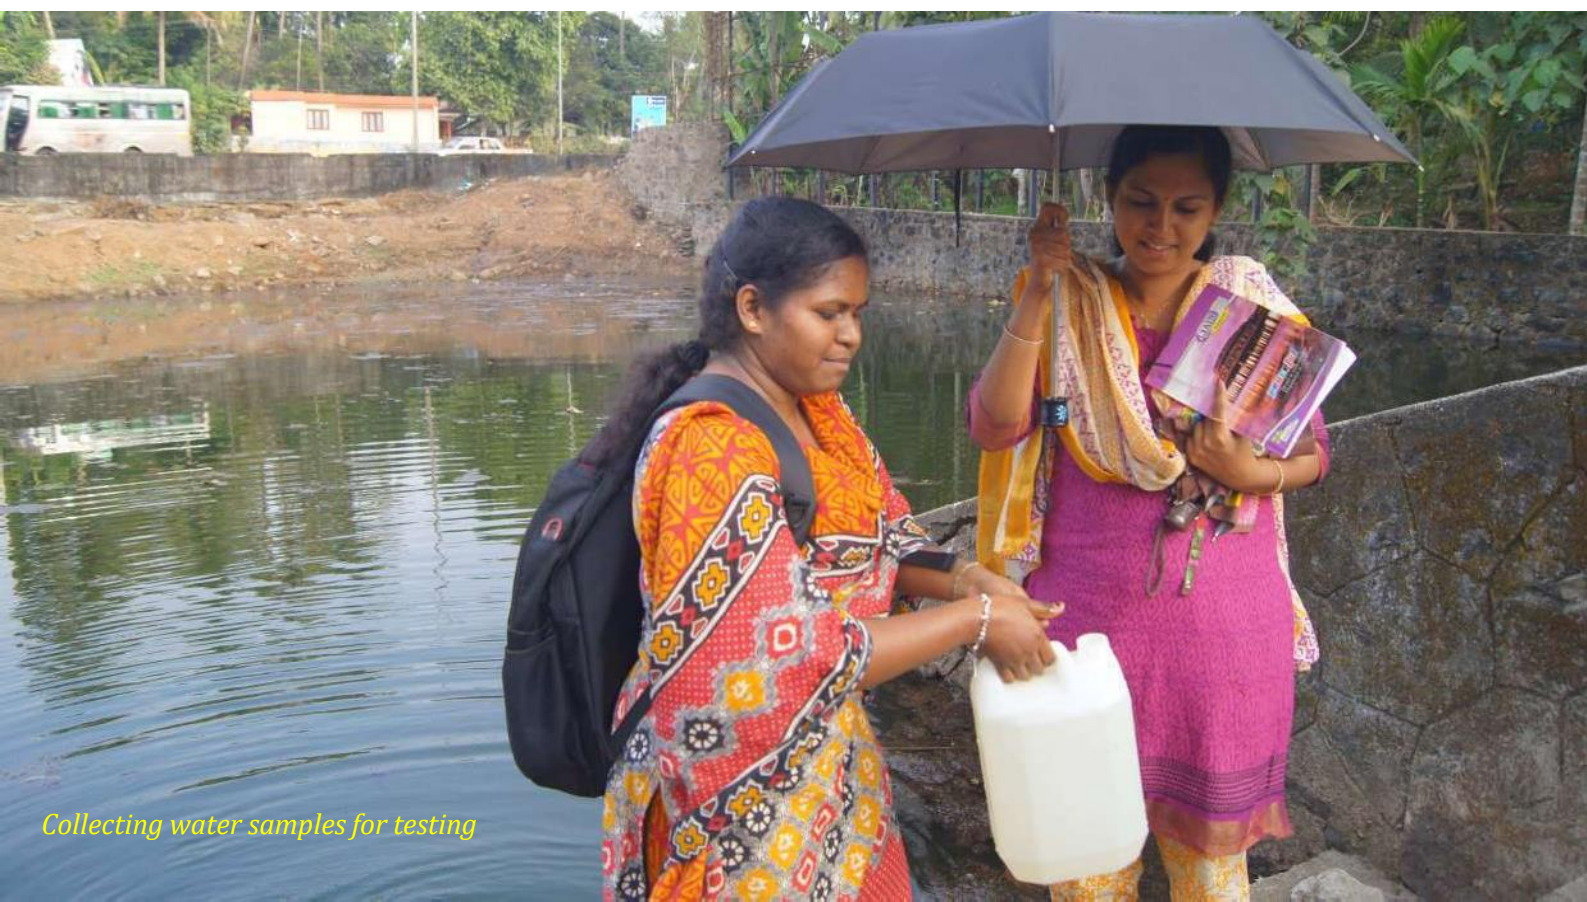
Collecting water samples for testing

As part of this study water samples were collected from the pond twice, covering a period of two months (January-February 2015) and the results are given in Table 9. The results shows that organic pollution is there mainly due to the decaying materials, but physical and chemical properties are within the standards (Indian and APHA) for open water bodies such as ponds (bathing and swimming purpose). It is well evident that Peringankulam is potentially enough to have a self cleaning mechanism maintained by the uninterrupted inflow and outflow system, provided the stagnation should be avoided and few aquatic plants should be retained. Absence of serious pollution or dumping of wastes is also noteworthy.
