PRE- PROJECT STUDY ON  
CONSERVATION OF RIPARIAN AND  
RIVER BIODIVERSITY OF  
CHALAKUDY RIVER

MARCH 2016

## Report of Pre-project study on Conservation of Riparian and river biodiversity of Chalakudy River

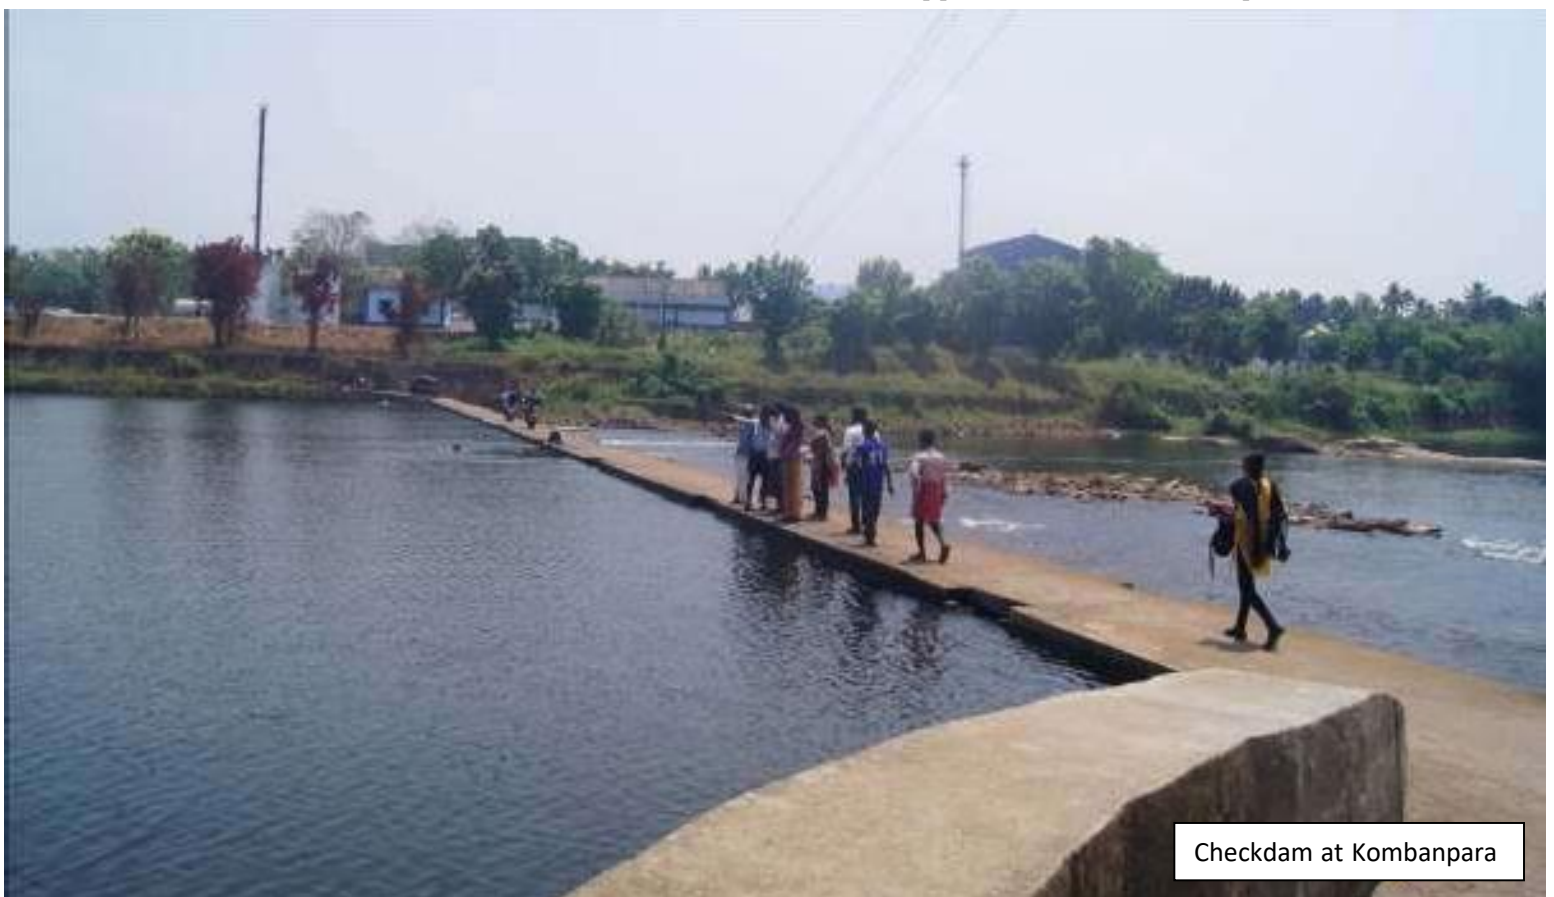
Checkdam at Kompanpara

The major problems related with these constructions are not only the reclamation of the to the unscientific construction and due to lack of maintenance also negatively affected the riverine system. Blockage of the river at many places has resulted in the alteration of flow of river and serious damage to the riverbanks. One incomplete barrier across the river at Vettukadavu of Chalakkudy municipality caused massive flow on one side of the river and has resulted in serious erosions of the banks on the opposite side. The same phenomena

has noticed in left side of Njaralakkadvu Bridge where the continuity of the river has been blocked using clay and other materials and left a small area on the left side. They did not remove the clay after the construction and has deposited waste of construction material in that region. Consequent blockage of the river and increased flow on the left side has seriously damaged the left bank and destroyed the houses. And now local bodies are funding for the construction of walls for the protection of the riverbanks.
